# Manhole Inspection Summary

Manhole # S08CC2006MH

**Location** Address: **3821 GLENGYLE AVE**

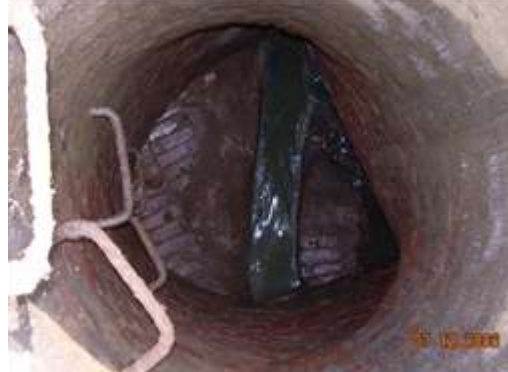
Top View

Adjustment and Barrel infiltration.  
Evidence of surcharge - Bench debris.  
Corroded steps.

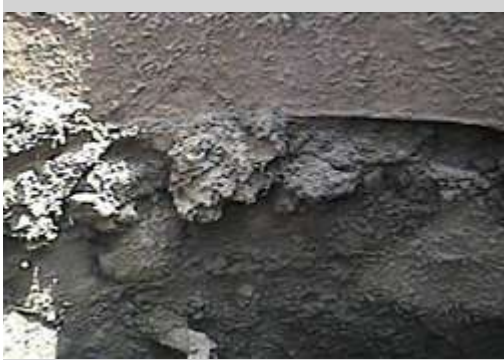
Defect

Frame leaks. Adjustment deterioration  
and infiltration.

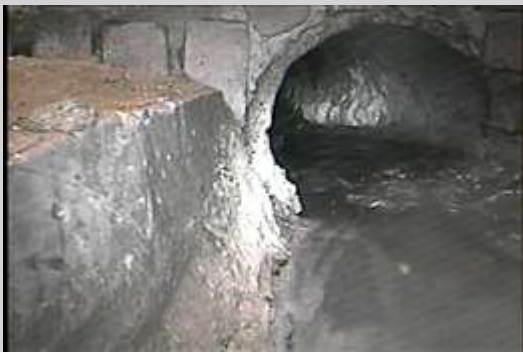
### 10 in. Circular Gravity Sewer Pipe Out @ 12 O'Clock

Comments **The O12 pipe picture shows Barrel and Channel deterioration. The I4 pipe picture shows Channel debris.**

Pipe Material: **Clay** ☐ Pipe Lined

Infiltration: **None** Pipe Seal Cond: **Sound**

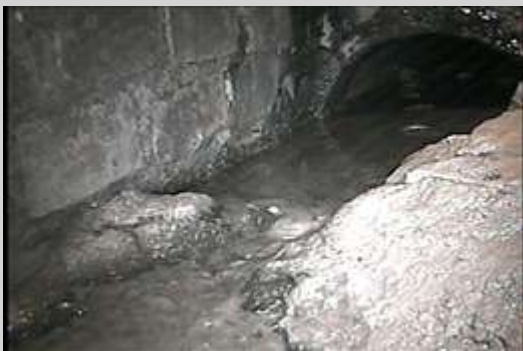
### 6 in. Circular Gravity Sewer Pipe In @ 4 O'Clock

Deposits: ☐ None ☒ **Mud** ☐ Sludge ☒ **Debris** ☒ **Grease**

Silt Depth: **2** (in.) Deposits Extent: **Medium**

Infiltration: **Evidence** Pipe Seal Cond: **Unknown**

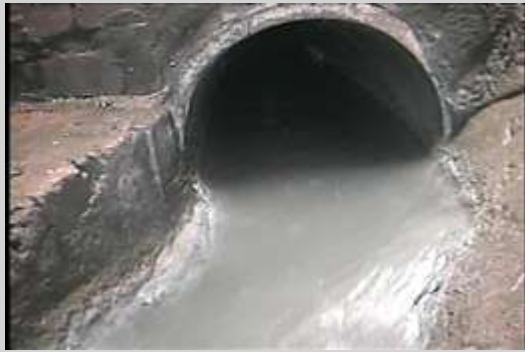
10 in. Circular Gravity Sewer

Infiltration: **Evidence**

Pipe Seal Cond: **Cracked**
